TRADITIONAL URFA DWELLINGS:
AN INVESTIGATION OF PART OF THE OLD TOWN CENTER

A THESIS SUBMITTED TO
THE GRADUATE SCHOOL OF NATURAL AND APPLIED SCIENCES
OF
THE MIDDLE EAST TECHNICAL UNIVERSITY

SEVİL İŞİL ÖREN

MAY 1996

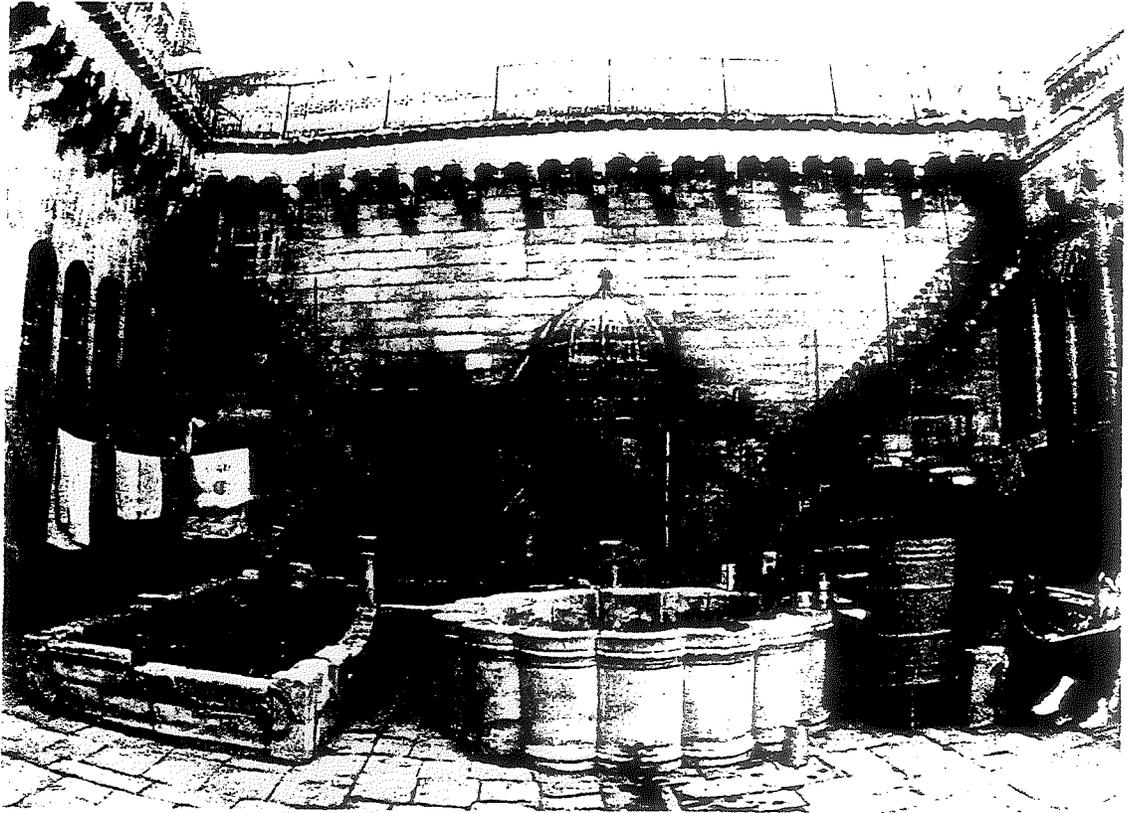
Figure 19 Courtyard of Akyüz House (Akkoyunlu, 1989).

polygonal in shape. It may also be in elaborate geometric forms as the one in the Akyüz House. The pool, in corporation with greenery and various trees, creates a microclimate in the courtyard in summer and decreases the stressful effect of the heat.

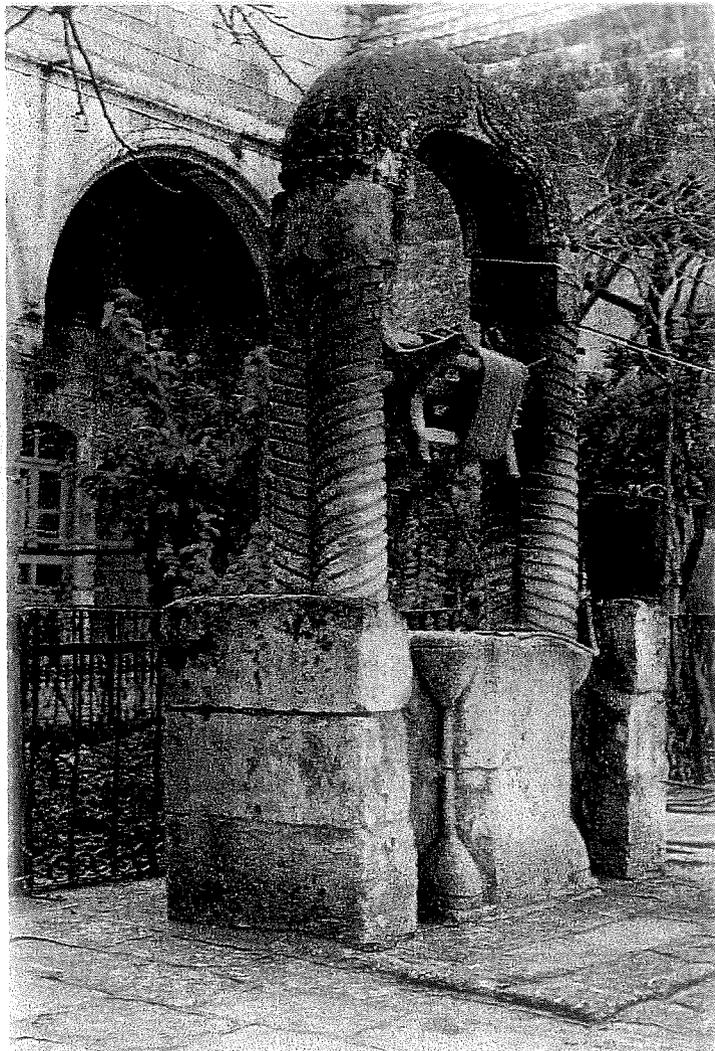
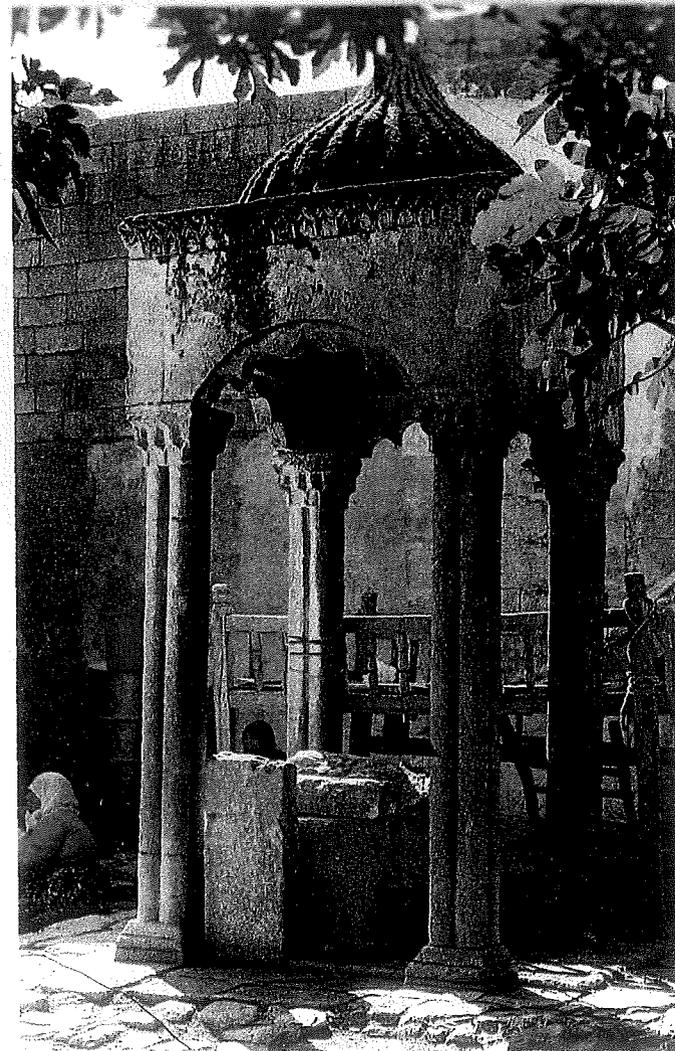
Figure 20a-b The wells in H. İmam Demirkol and Mehmet Kandiran Houses (Kürkçüoğlu, 1988).

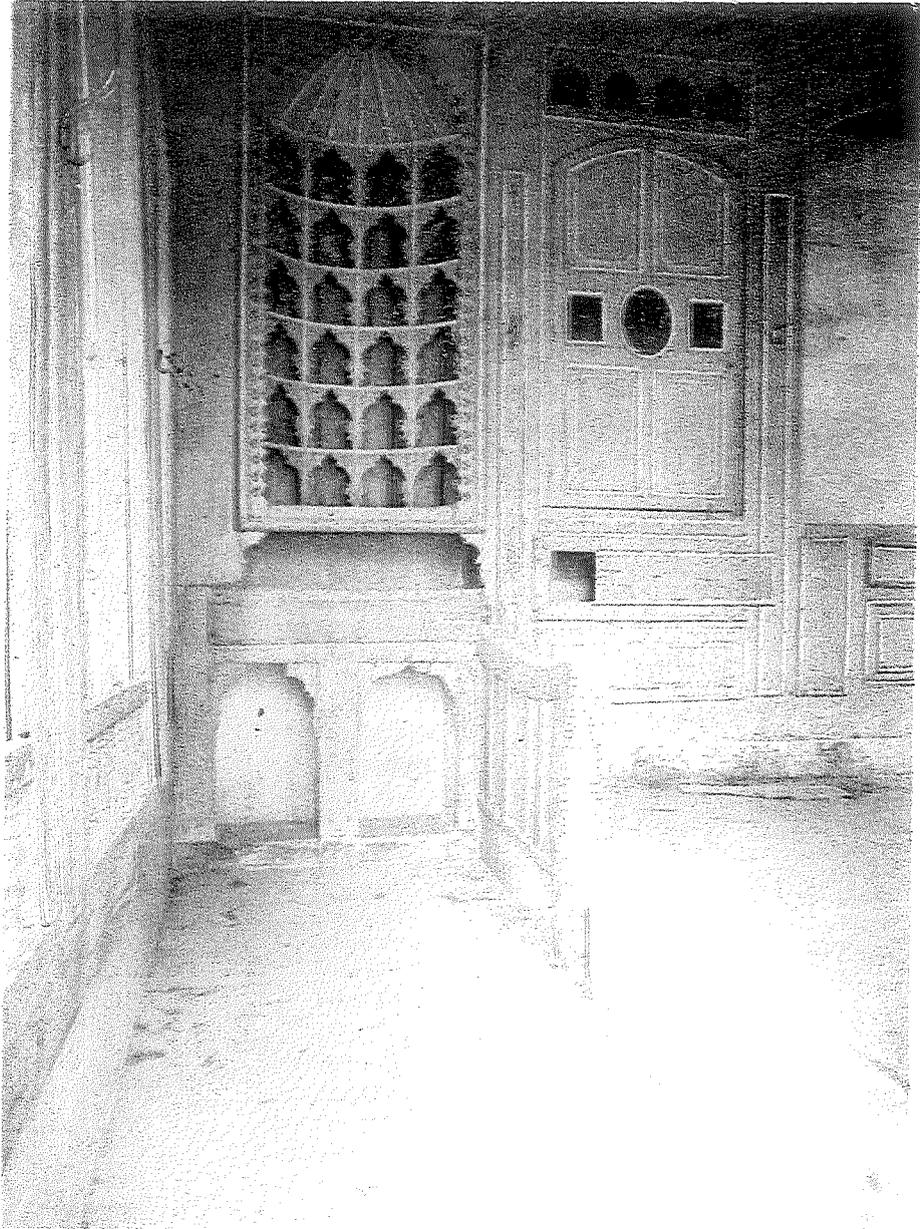
Figure 27 "Gedemeç" and built-in cupboards in a room of Hacı Bekir Pabuçcu House (Akkoyunlu, 1989).

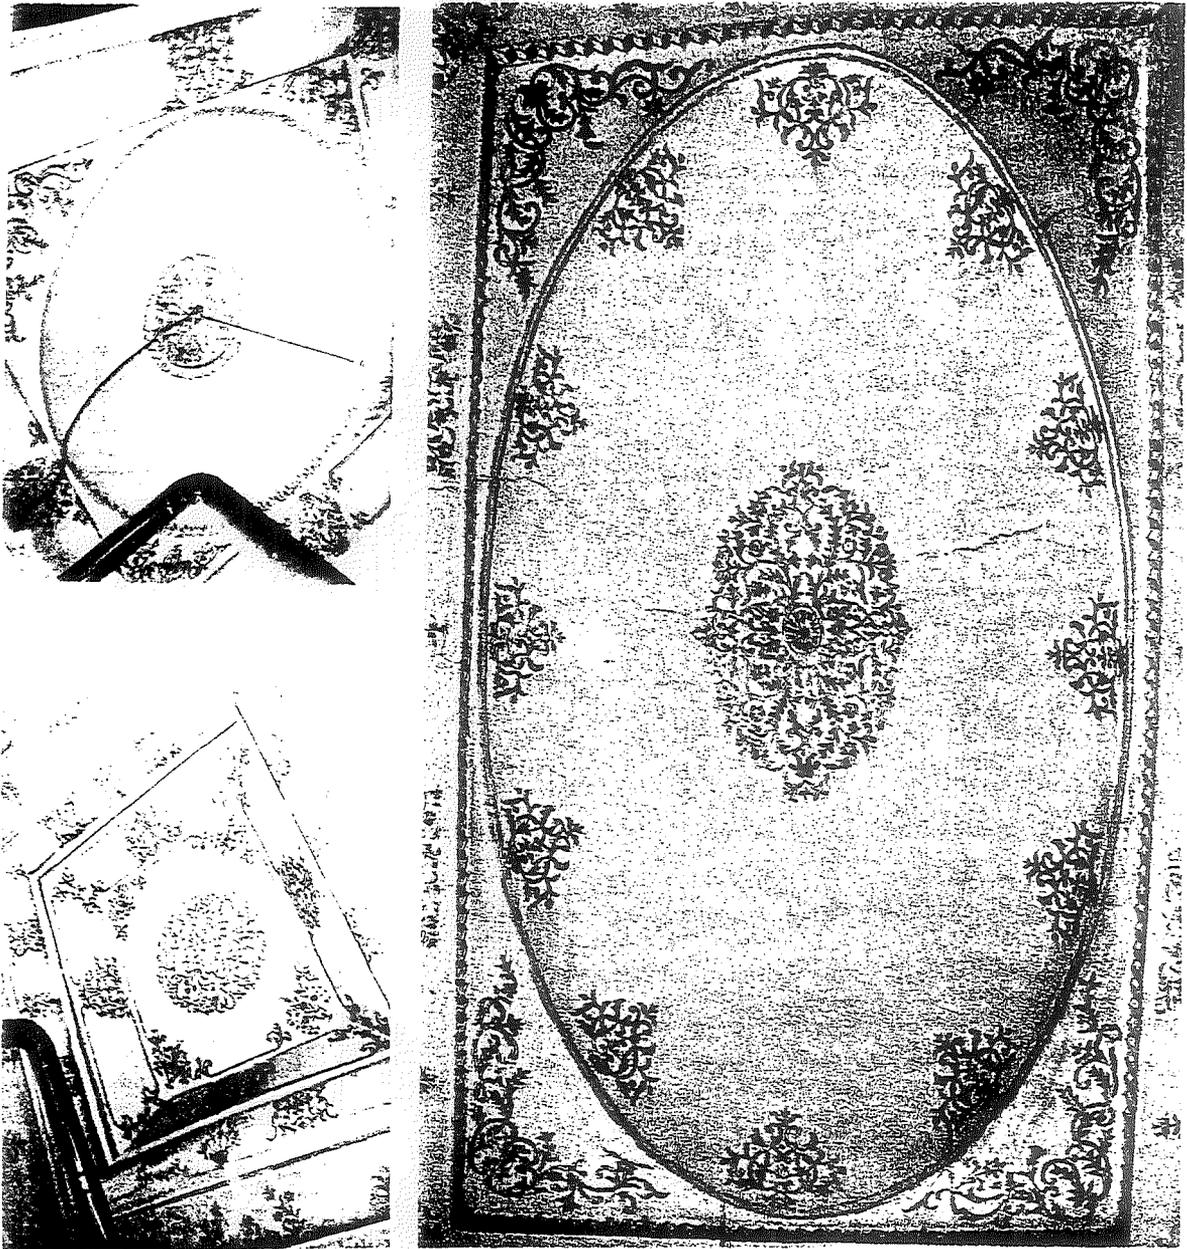
Figure 29 Decorated plastered ceilings in square, circular and elliptical forms in Bedri Pınarbaşı House (Akkoyunlu, 1989).

The rooms have either stone vaulted or flat timber ceilings. Much attention is paid to the decoration of flat ceilings out of timber. Flat ceilings are left as exposed logs or covered by ornate wood sheathing. Some of them have decorated timber or plastered ceilings in rectangular, square, circular, or elliptical forms, sometimes painted in floral motifs.

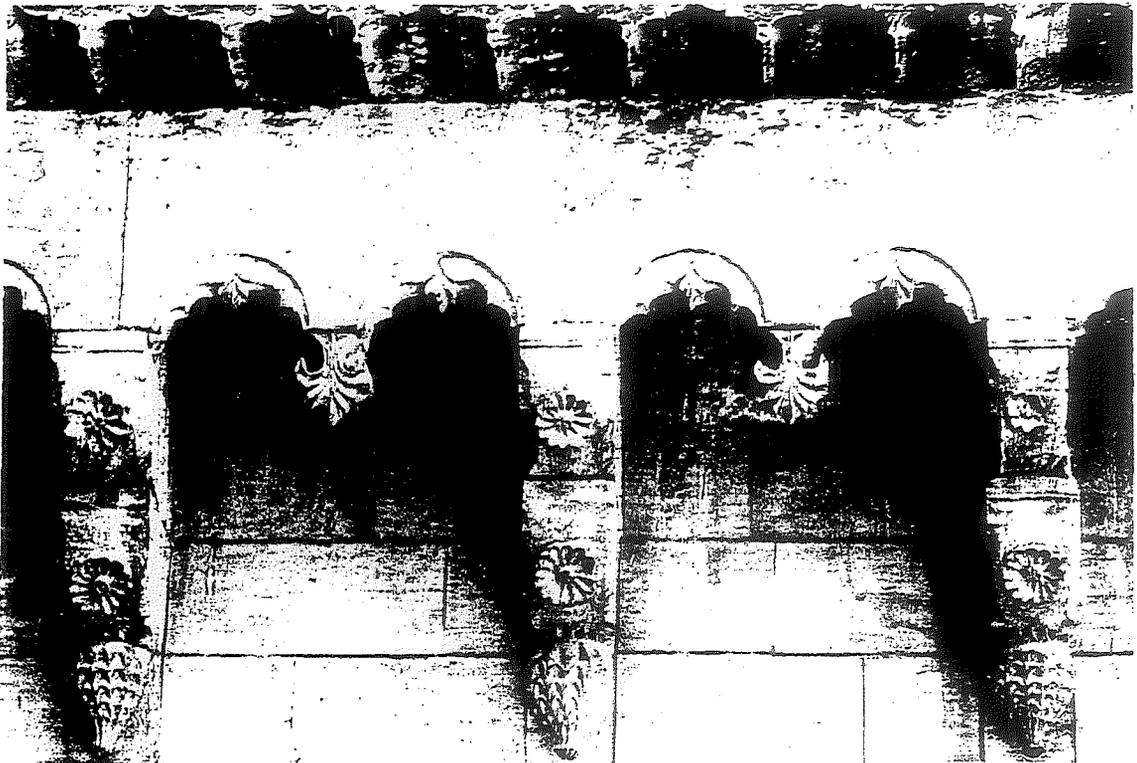
Figure 30 Decorated “gezenek” projections of Akyüz House (Akkoyunlu, 1989).

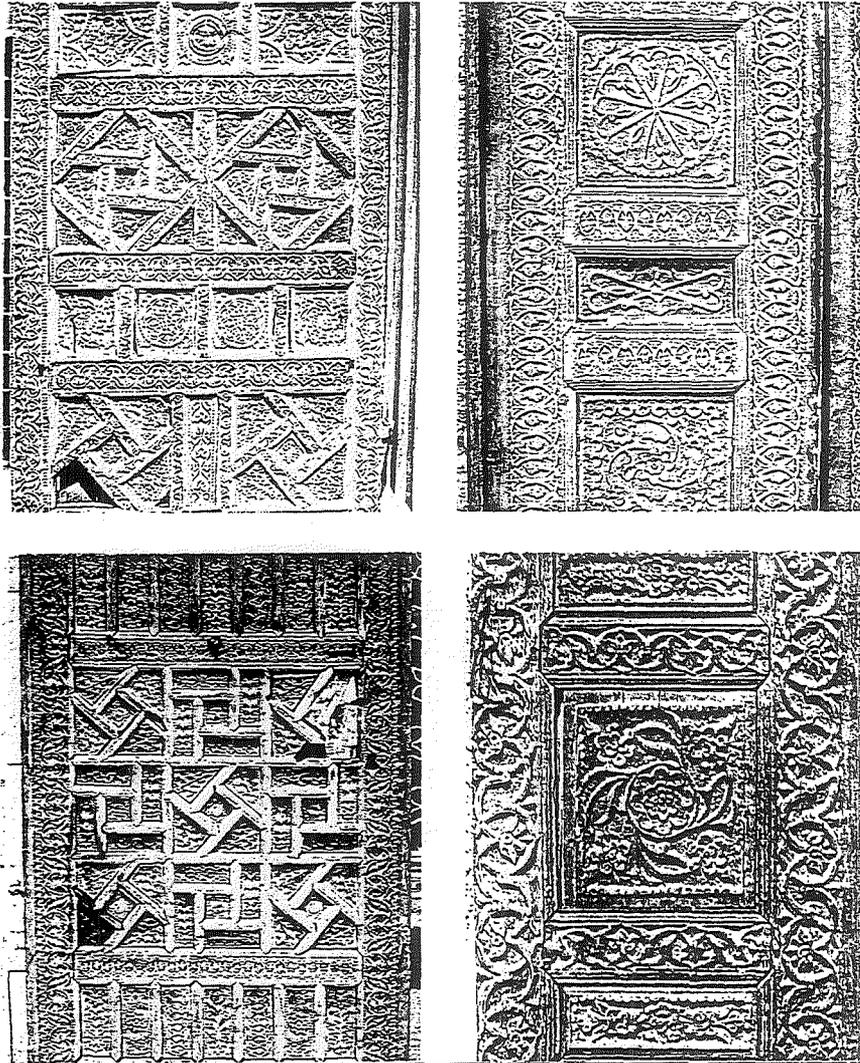
Figure 33 Examples of timber decoration in traditional dwellings (Kürkçüoğlu, 1988)

Timber is also used in lattice form covering the street windows to prevent an outsider to see the one who looks through it. In addition, it is used as a structural element, in the form of beams ("cıdır") on both sides of the street projections.

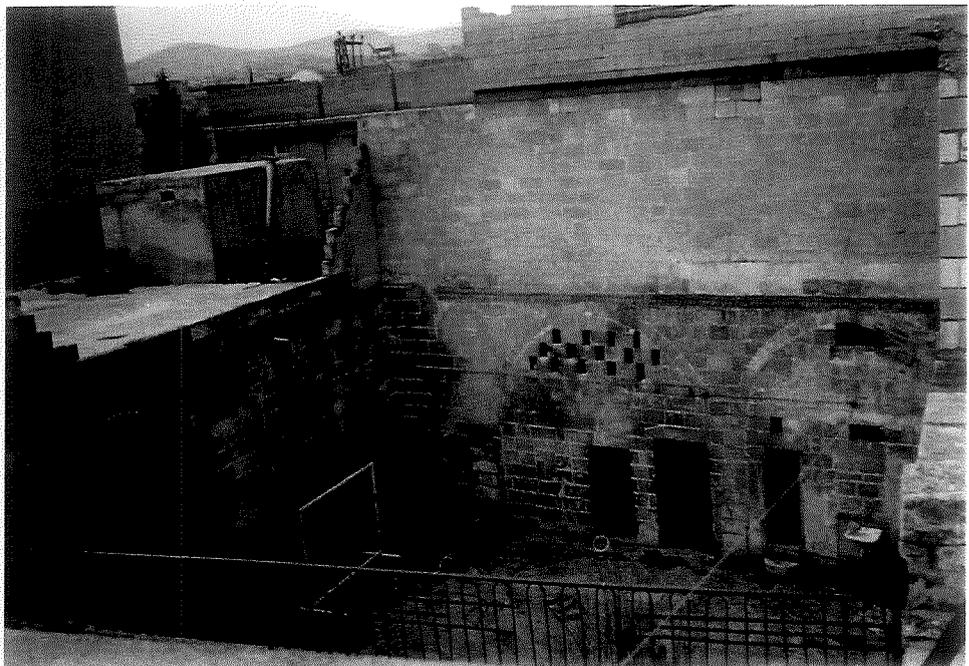
Figure 48 View of the courtyard and west elevation of Erkasap House.

The **courtyard** is the central organizing element of the house, square in shape and 115m² in size. Its original stone pavement was replaced by concrete flooring later on. The garden in the center have been totally altered. There is no trace of the original garden, however the present one has a square shape (2.30x2.40m), enclosed by low concrete parapets. The well of the house as a prominent element is at the southeast corner, whereas the fountain which was added later providing city water is at the west wall of the courtyard. The staircase in the south leading up to the flat roof was built later on, made of reinforced concrete.

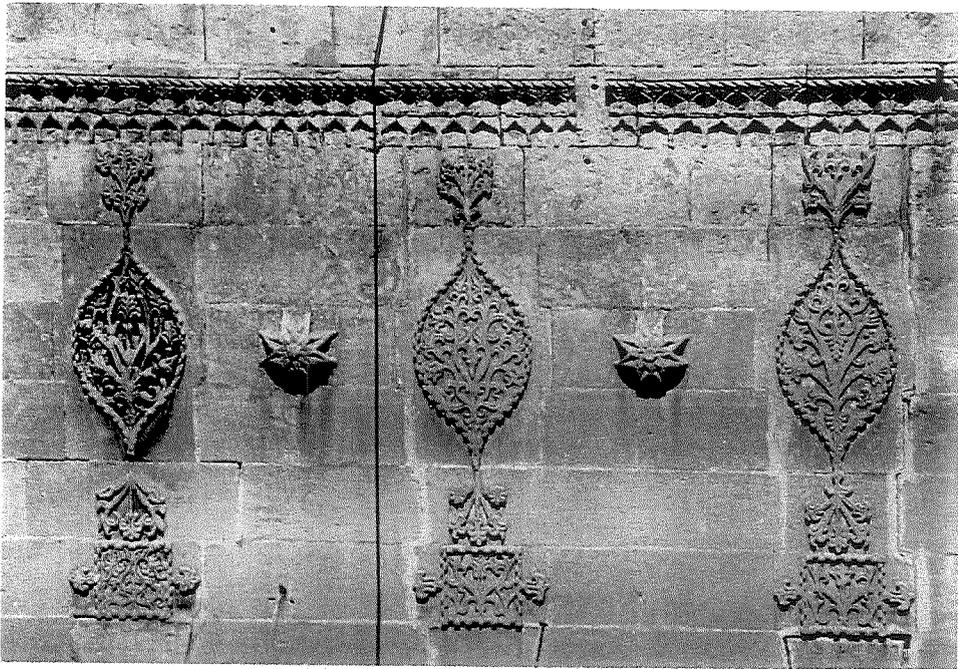
Figure 62 Detail from the stone decorations on the north elevation of the "haremlık" part of Yorgancı House.

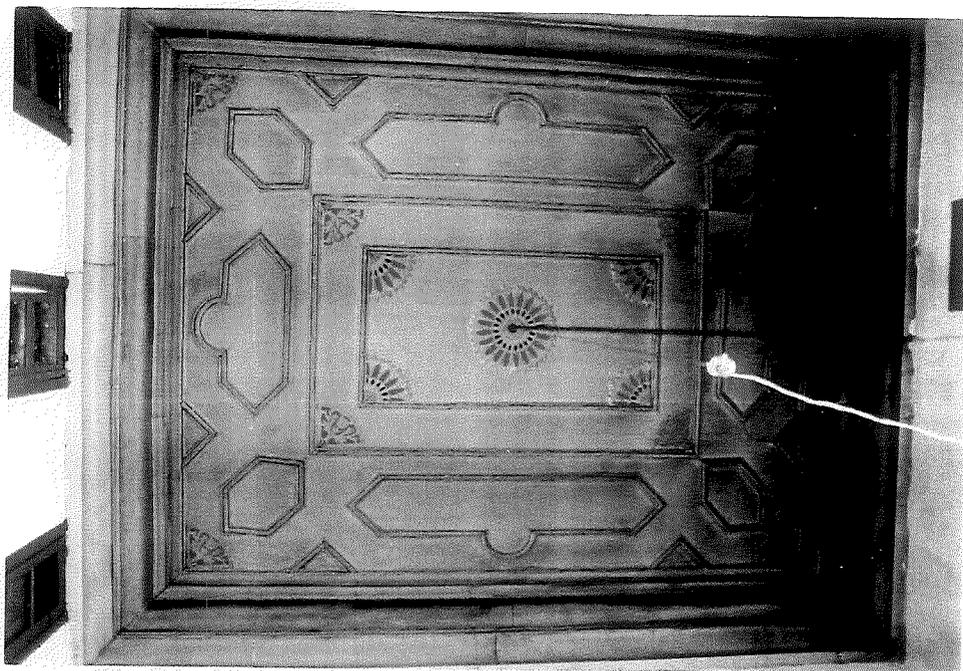
Figure 71 Decorated timber ceiling of the room in the west of the summer “eyvan”. “Haremlik” part of Yorgancı House.

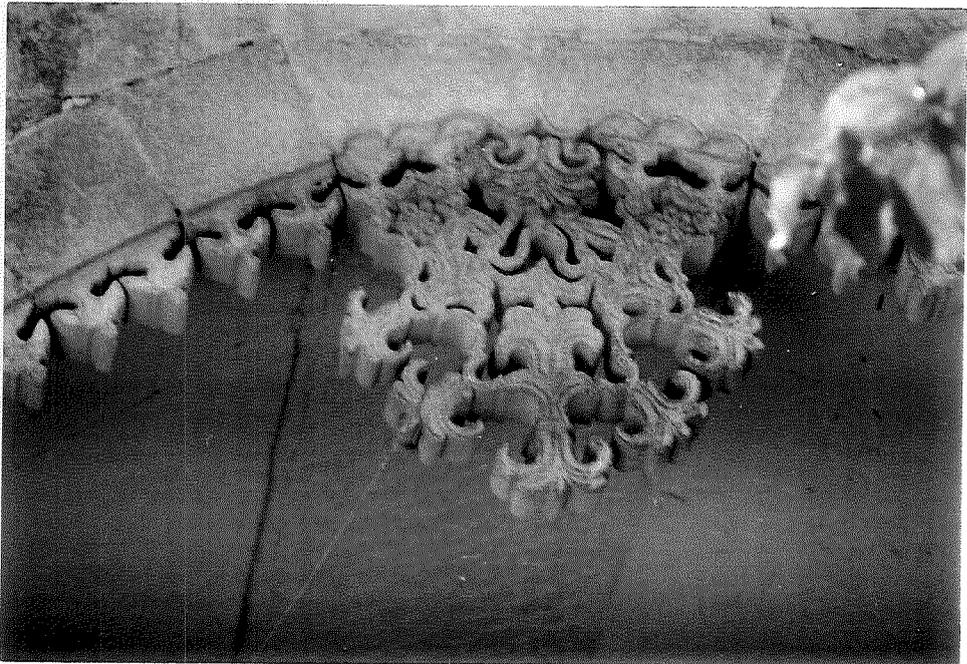
Figure 86 Keystone of the summer “eyvan” of “haremlik” in Güllüoğlu House.

The summer quarter is the most attractive part of the house with its space quality and elaborate courtyard elevation. It consists of two rooms with an “eyvan” in the center. The “eyvan” opens to the courtyard through an intricately decorated semi-circular arch with a finely detailed keystone in the form of a bunch of tulip. It has a barrel vaulted ceiling with a band of relief in geometric motifs. The “eyvan” and the rooms are covered with cross vaults. These vaults have decorated geodesical stones at their apexes. The south wall of the “eyvan” has treated with tripartite niches. The windows and doors of the rooms looking to the “eyvan”, and the courtyard are symmetrically arranged. The courtyard windows are decorated with grilled stone elements in geometric shapes.

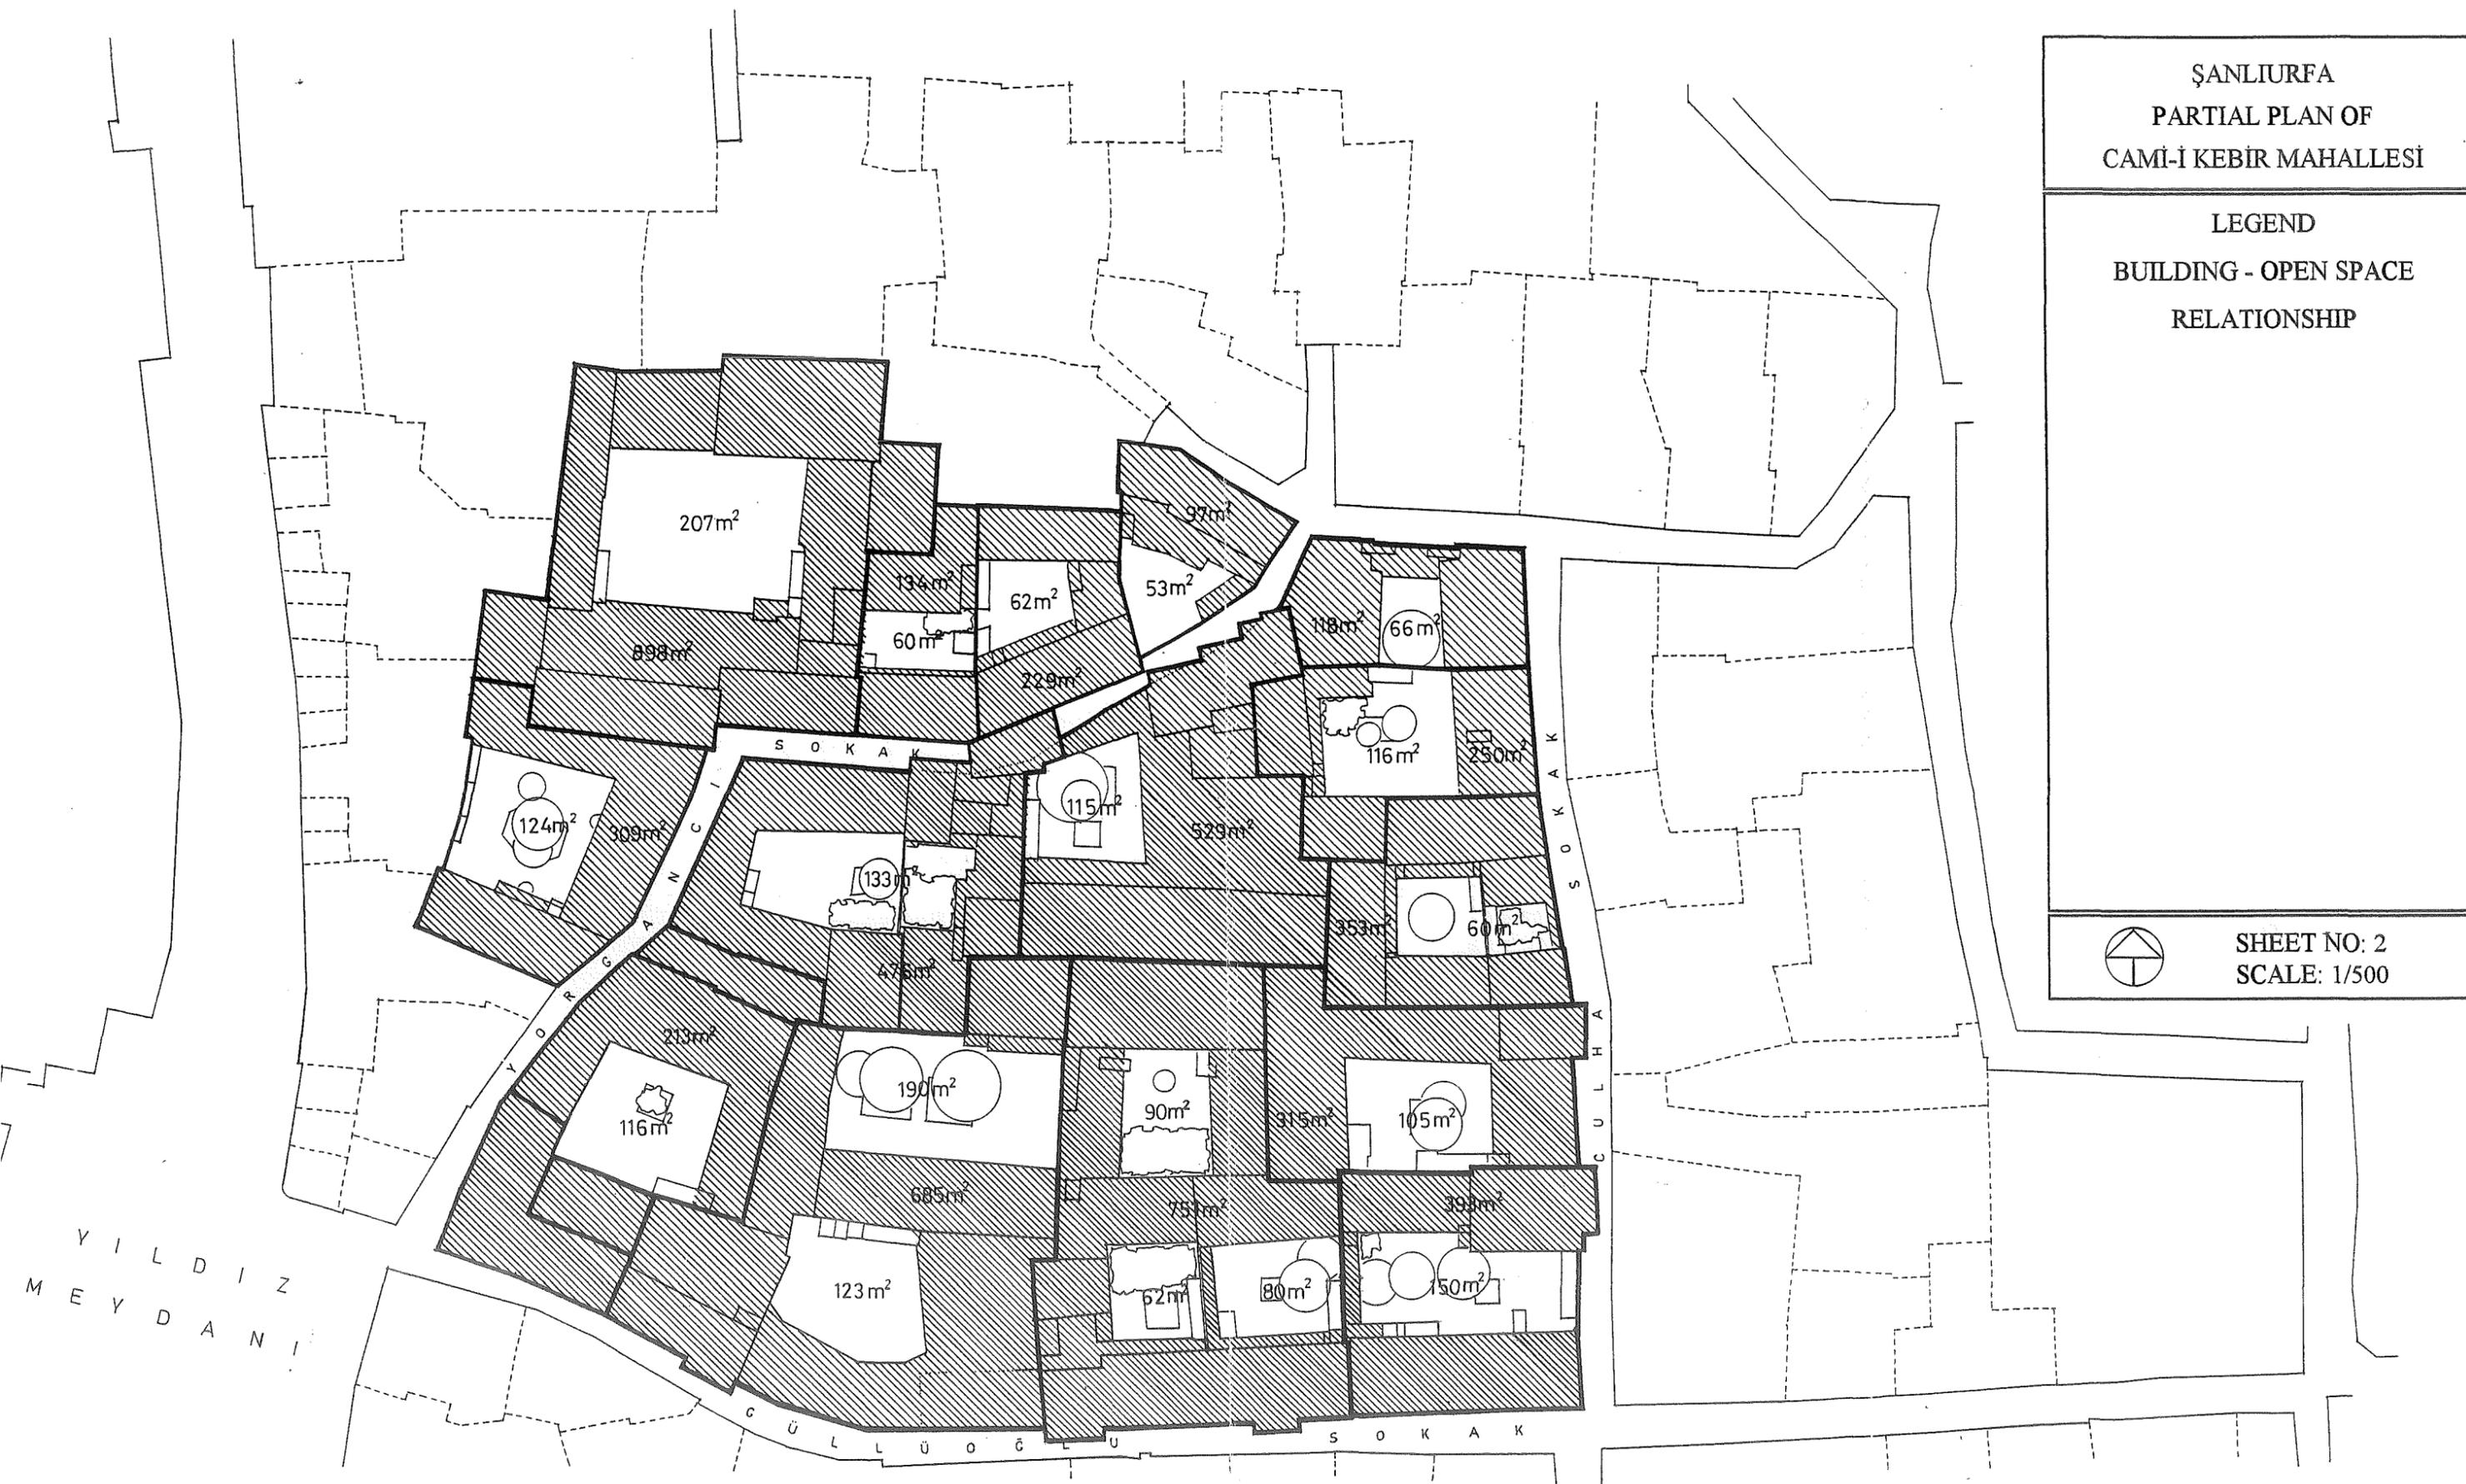
SHEET NO: 2
SCALE: 1/500

ŞANLIURFA
PARTIAL PLAN OF
CAMİ-İ KEBİR MAHALLESİ

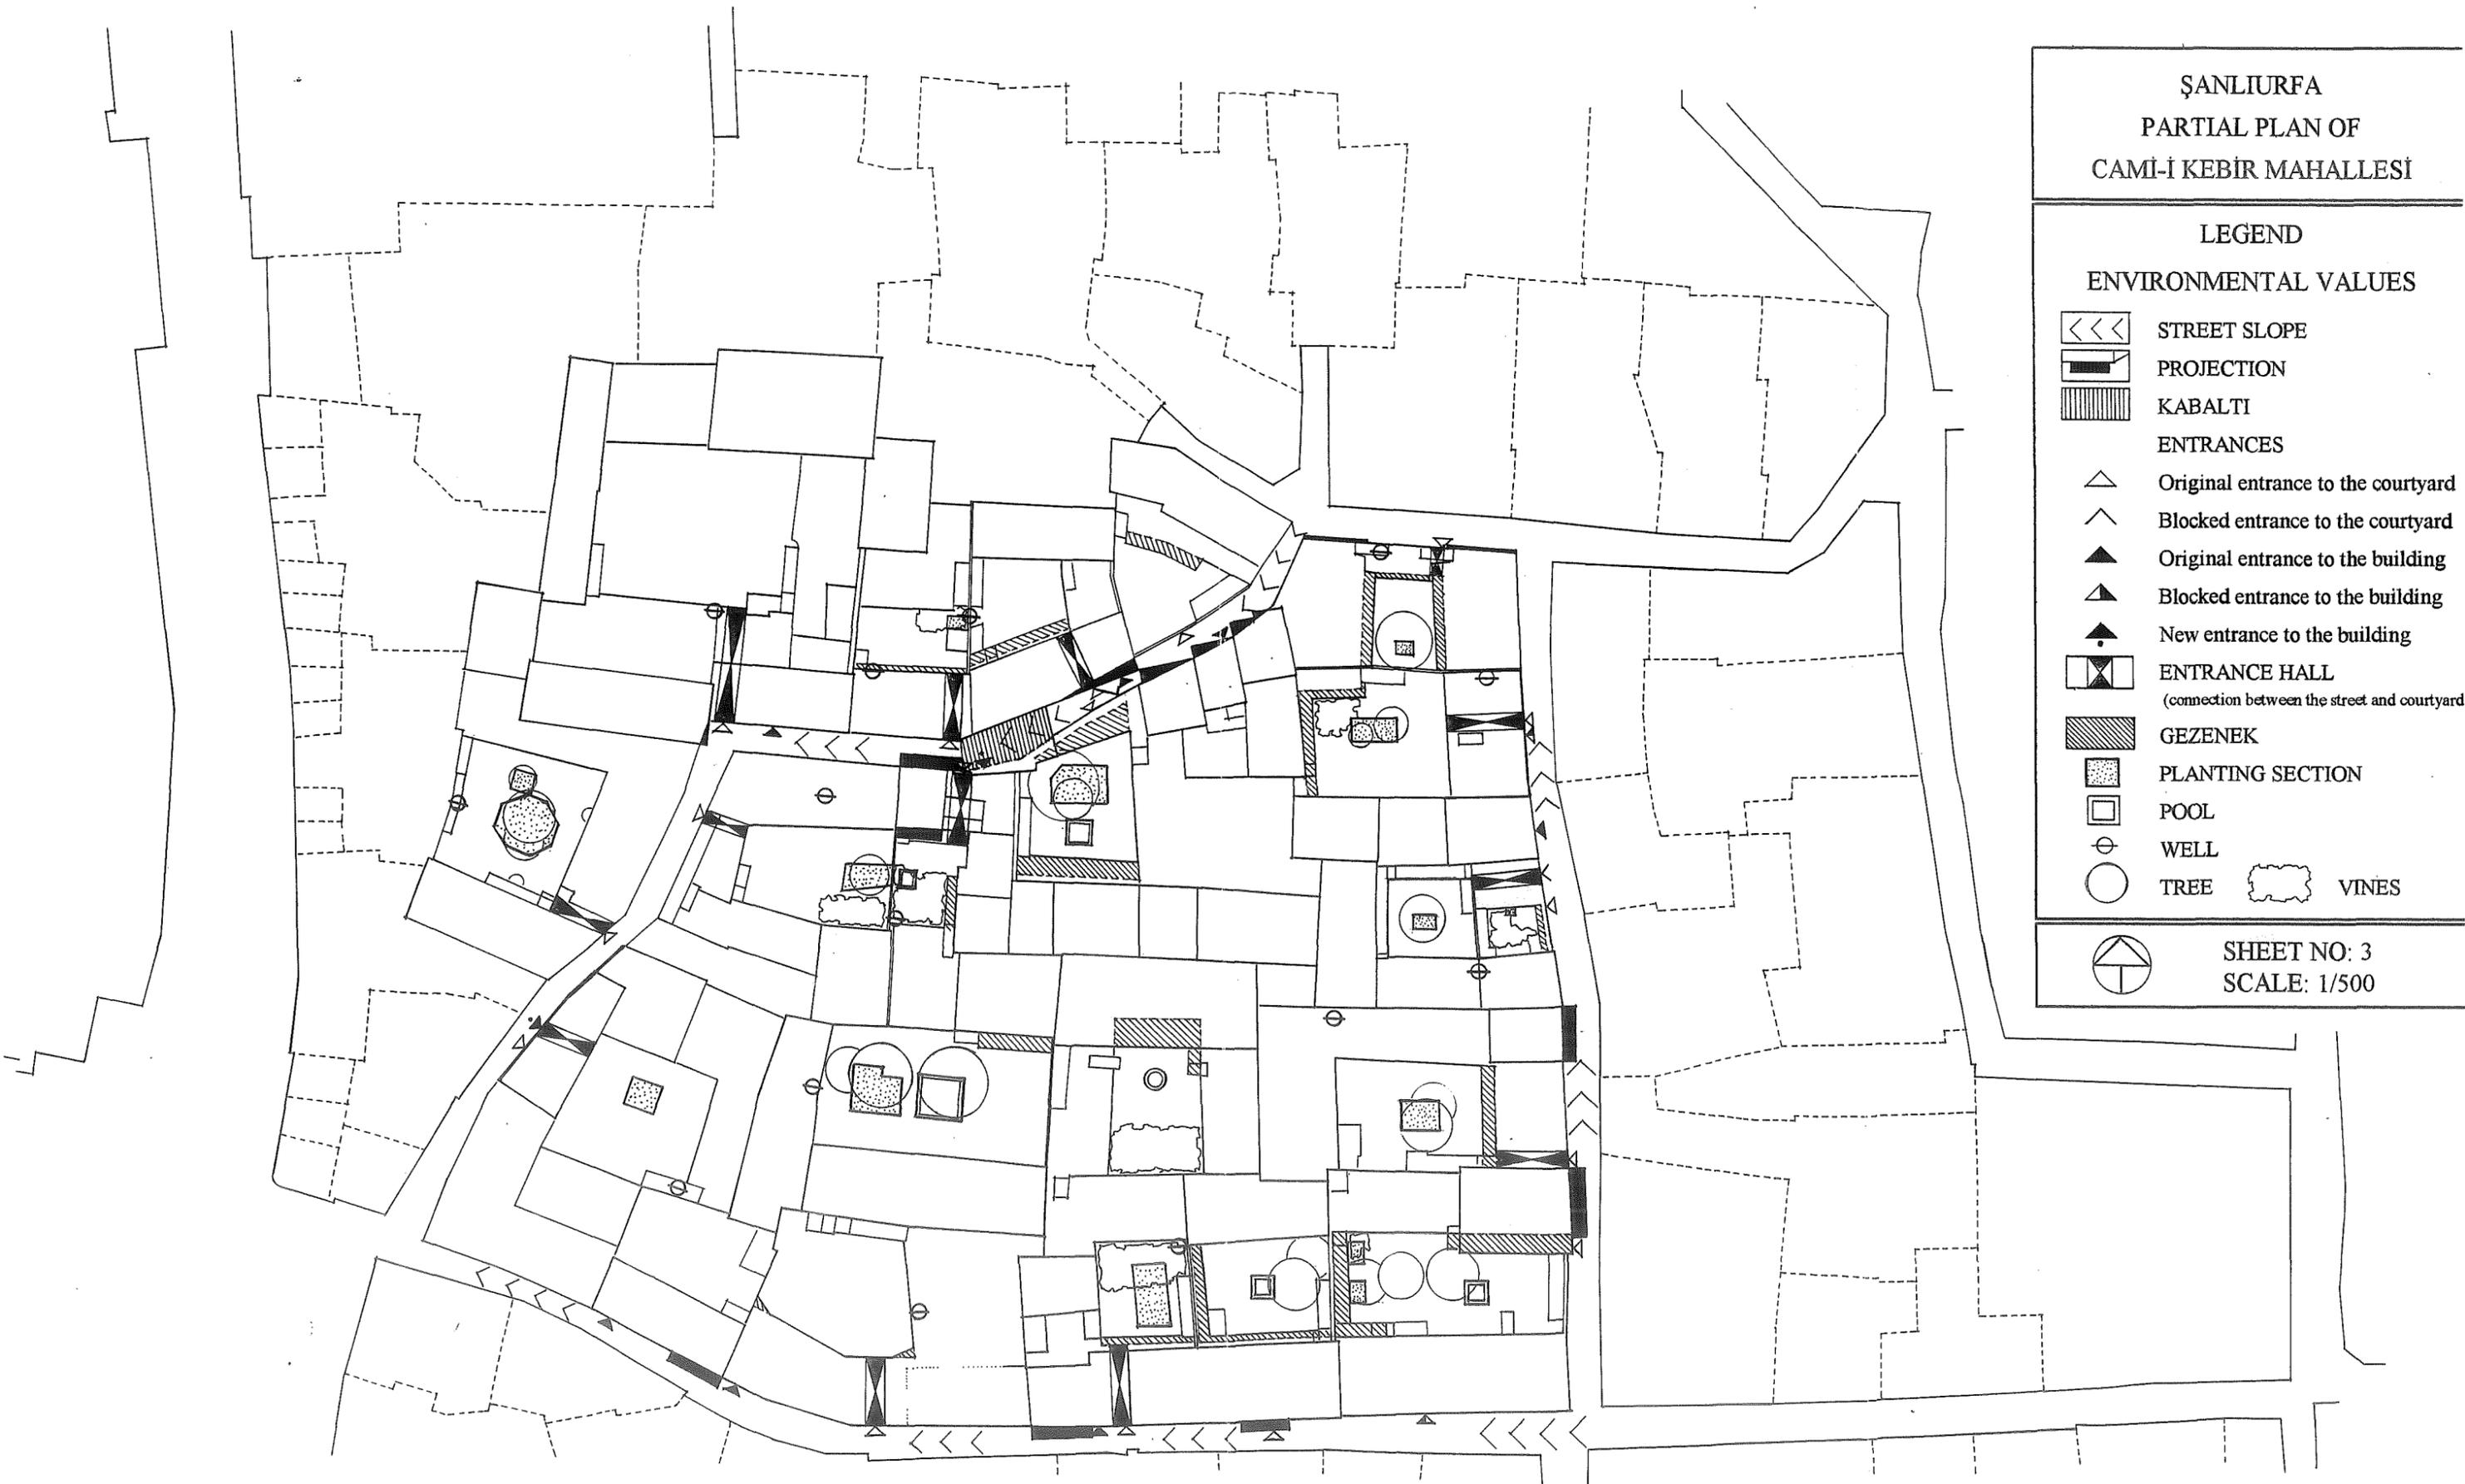
SHEET NO: 3
SCALE: 1/500

ŞANLIURFA
PARTIAL PLAN OF
CAMİ-İ KEBİR MAHALLESİ
